KILDALE MANOR REVIEW.

This Review will concentrate only on the Kildale Manor complex and will draw together all the available information about its history and archaeology.

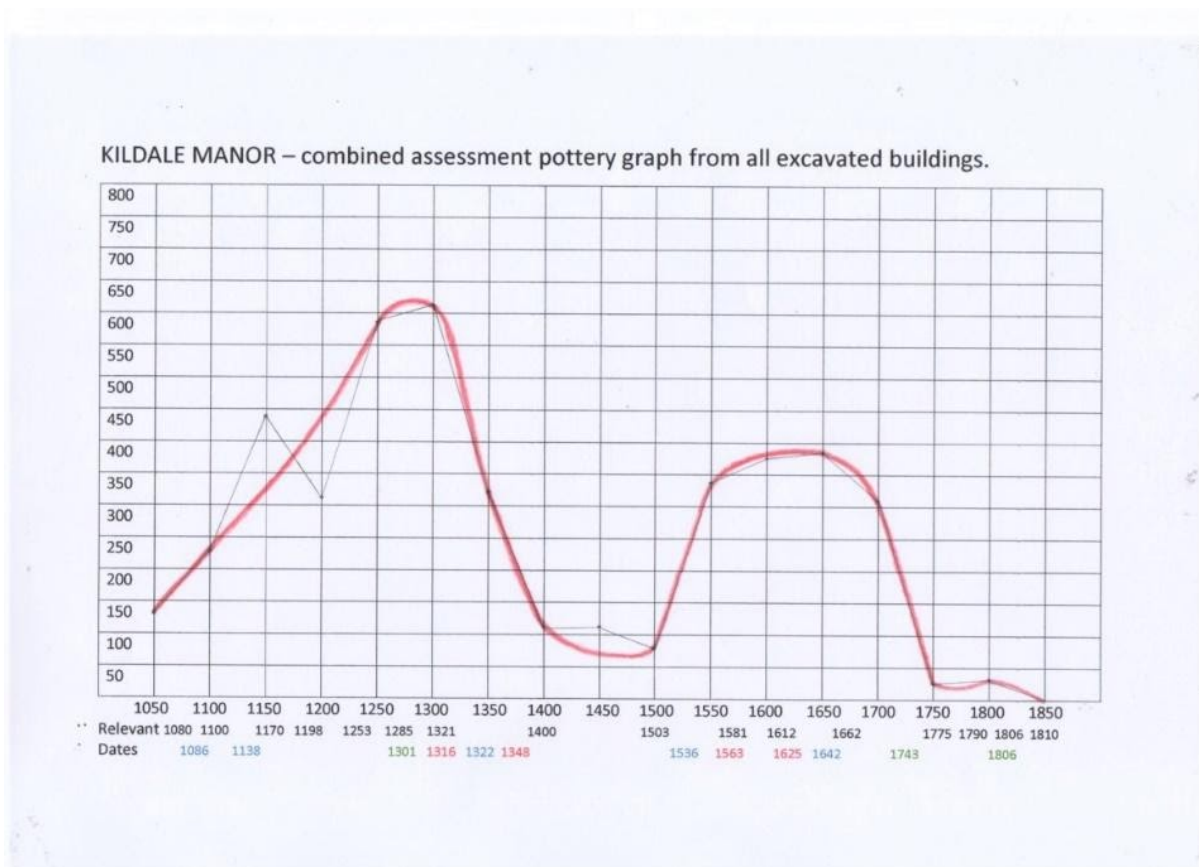
The above graph indicates the historical pottery volumes based on Anne Jenner's

assessment of the pottery from the 1957 to 1976 excavations now in the Dorman Museum.

Thanks to Ken Shaw (YAT volunteer) for the original graphs on which the above is based. The dates in black occur in the above text; national historical dates are in blue; Kildale population dates are in green; plagues and famine dates are in red.

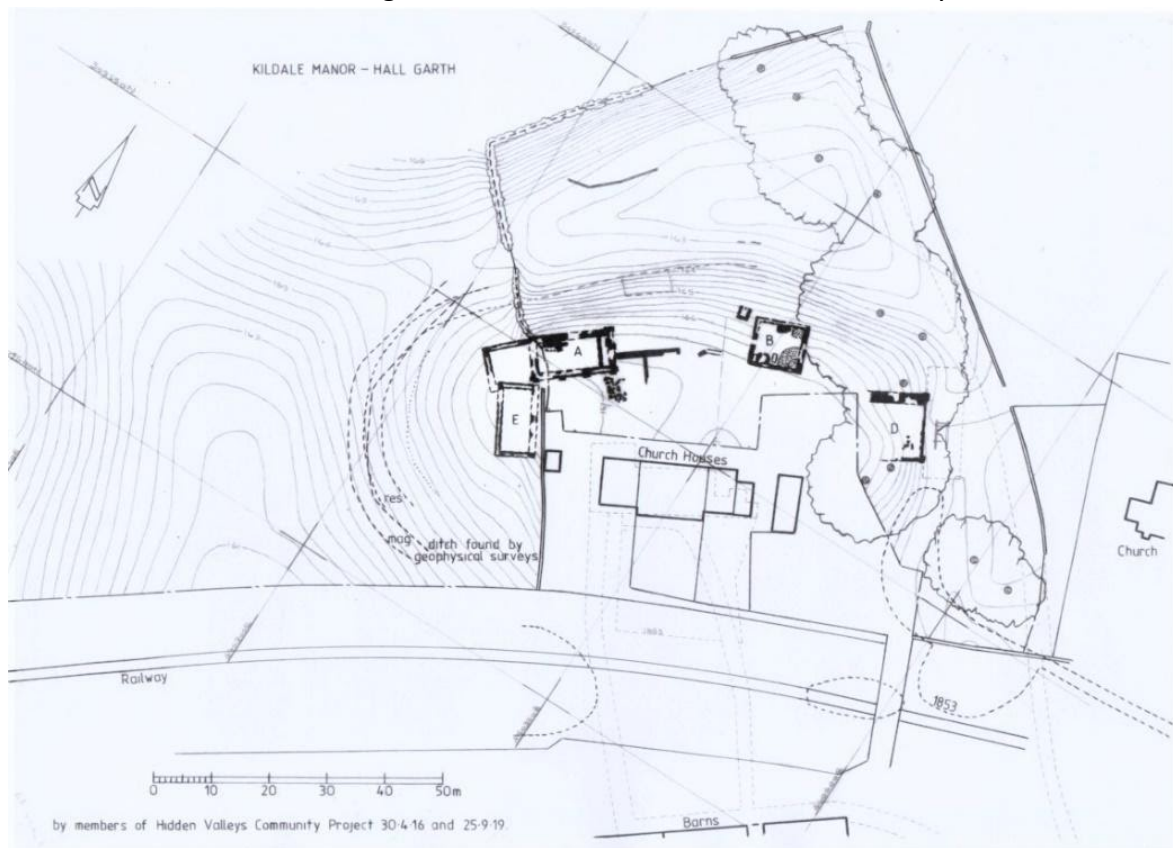
Below is a plan of the Kildale Manor complex based on the topographical survey undertaken by members of HVCP in 2019. Each building has been assigned a letter except for the western extension to building A. See the Problem Section for the validity of the letters.

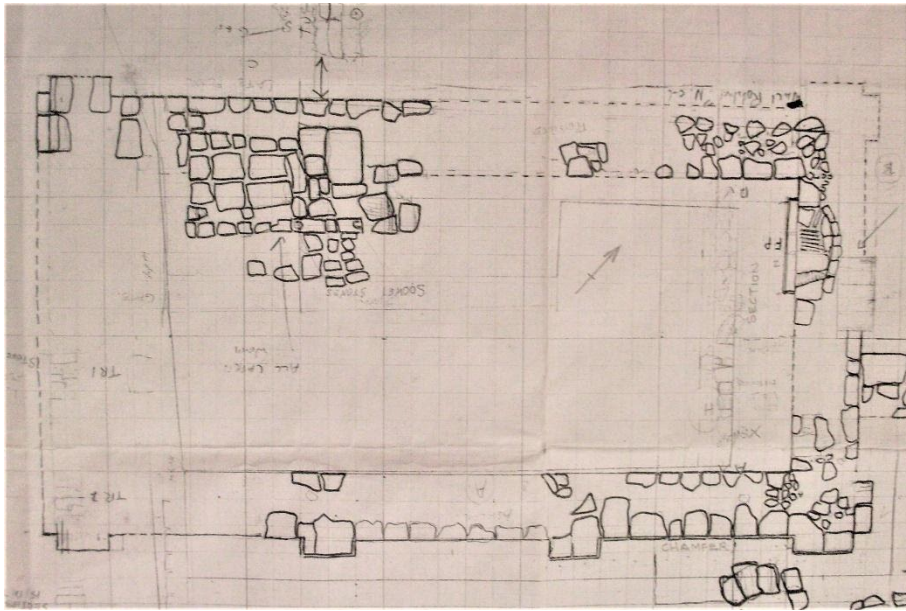
BUILDING A.

This building was found in 1961. It measured approximately 12.5m by 5.3m internally although the SW wall was not fully defined. There were five fully defined buttresses, three on the SE side, one on the NW side and one on the NE wall. Where the walls were defined, they measured 1.2m wide. The exposed SE wall had a 45deg external chamfer as shown in the photographs below.

An internal wall appears to have been added later 1.1m from the NE wall and measured about 0.6m wide. The above section represents the NE face of this wall which lay on top of a layer of clay and rubble containing some moulded stones - possibly an earlier occupation layer which in turn lay on another clay and rubble layer containing burnt stones, pottery and part of a sword hilt.

The majority of the SE wall was well constructed using ashlar blocks with chamfers and surviving to its original height of 0.6m. It had a flat and level top with a rubble filling. This is in marked contrast to the walls on the NE and NW sides where the construction seems to be much more random and of poorer quality. On the SW side walling was found in two trenches and was not well defined (see plan above).

A good quality fireplace was found in the NE wall which measured about 1.5m by 0.6m. From the plan it appears to have had a narrow hearth.

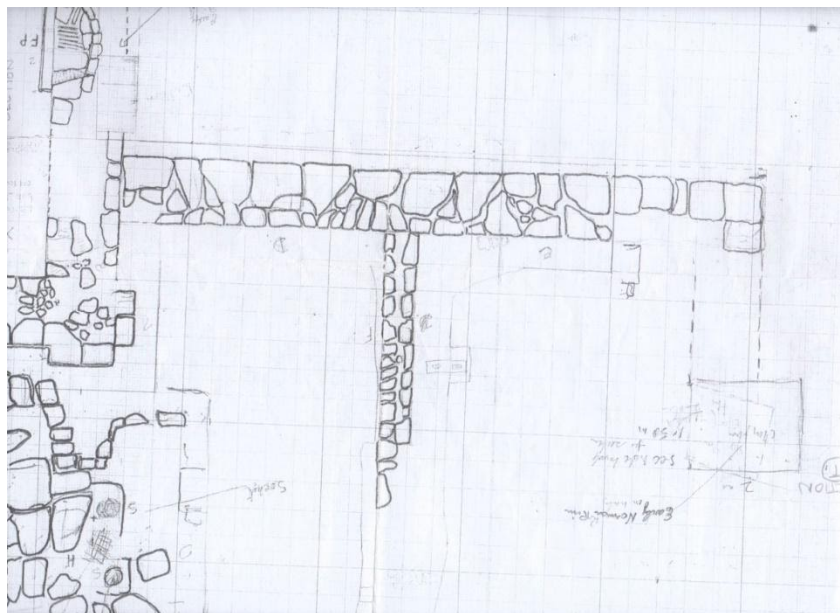
Abutting the NE wall of the building was a later wall which extended 11.3m NE from the building and measured 1.2m wide with another narrower wall at 0.5m wide abutting the former wall (see plan below - the wall on the left is the NE wall of building A). The purpose and date of these two walls is unknown.

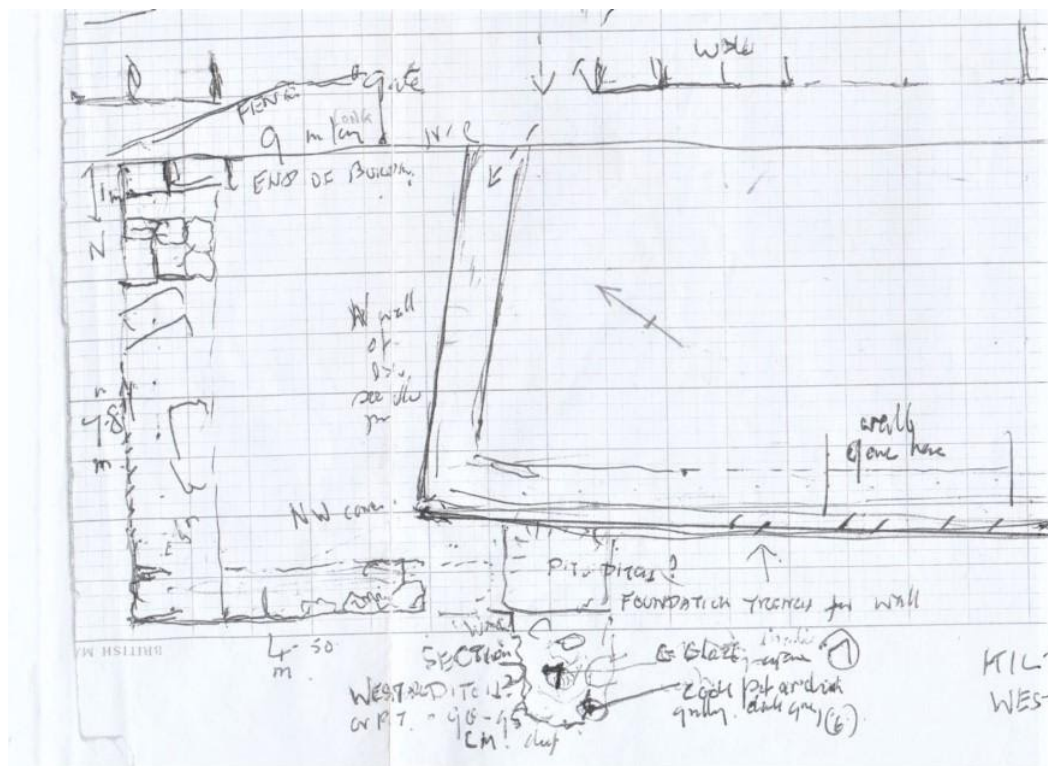
WESTERN EXTENSION (to building A).

This building is on the left on the above drawing. The rhombic shaped building is building E. The relationship of the extension to buildings A and E is not clear from this drawing and there are no notes in the archive describing this building. It is assumed that it abuts building A but looks to have been truncated by E ending in a foundation trench, although Raymond also describes this trench as a possible ditch or pit (see above). The NW wall measured 7.8m externally and the stonework of the SW wall extended for 4.5m. The walls measured about 1.4m wide.

Whether or not this building is contemporary with A is impossible to ascertain, although being apparently truncated by E would suggest that it was earlier than E. Alternatively this building could have been constructed at the same time as A and E, or later, as a store infilling the south-western corner of the Manor complex.

This is the only drawing of this building.

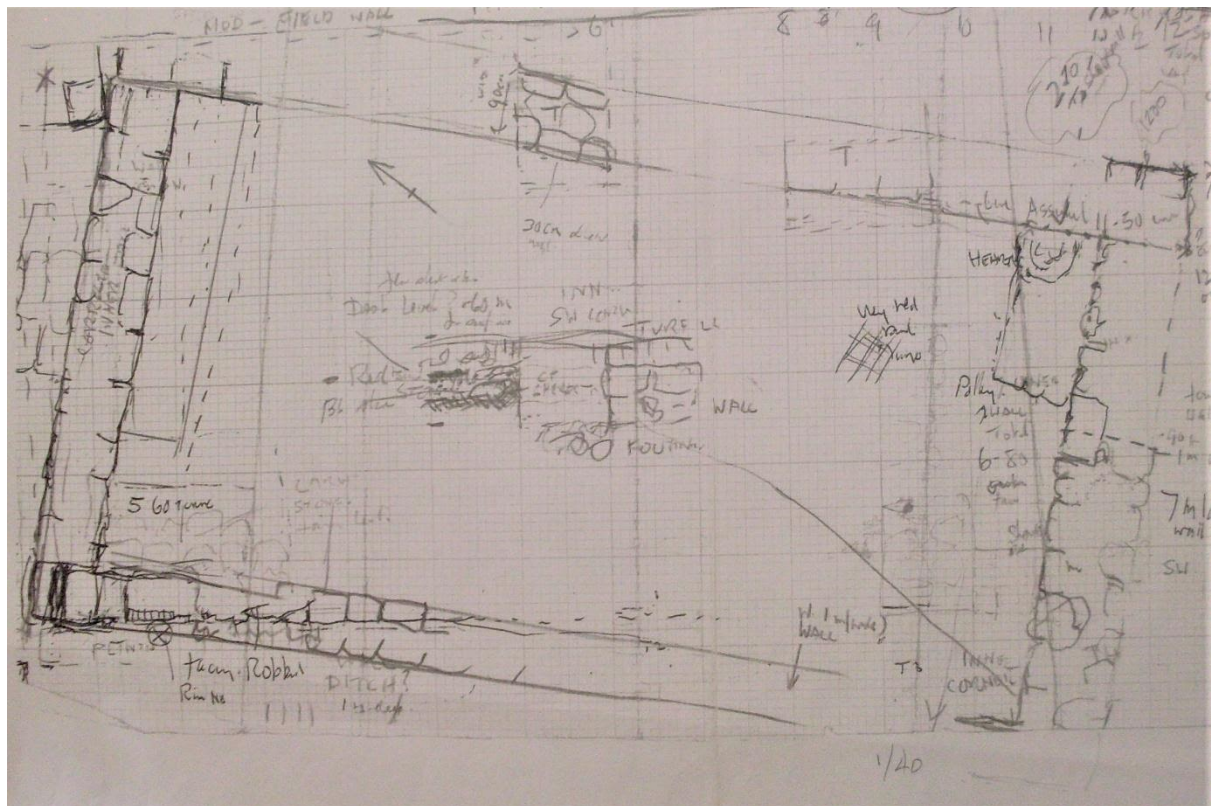
BUILDING E.

Building E was found in 1974 in the stubble field next to the grass paddock in which buildings A, B and D were found. Its position and alignment were confirmed by the resistivity survey undertaken in 2019. This is the only building which has a good series of drawings - three plans and three sections drawn by Raymond Hayes of which the above plan is a good example. There are ten pages of notes relating to this building (4 originals, 3 rewrites and 3 duplicates) in Raymond's archive stored in the Ryedale Folk Museum.

Building E measured about 10.6m NW-SE internally or 12.5m externally and about 6.8m NE-SW internally or 7.1m externally. The walls vary in width and quality but the average is about 0.8m. Dressed ashlar stones with chamfers were found at the NW corner (1.26m long), at the SW corner (1.0m long) and possibly in the middle of the NE wall, all surviving to 0.4m to 0.5m above the footings. Several courses of stonework were found in the NW wall near the NE corner. The majority of the SW wall had been robbed out and the central part of the SE wall consisted of random stones changing to large stones set in brown/yellow clay and gravel over 1.0m deep nearer the SW corner (see section below – this and two other sketches are the only section drawings for this building).

A hearth was found inside the SE corner which measured about 2.0m by about 0.9m wide (see above plan). A large area of tumbled stones was found inside the building about 1.0m from the SE wall. Another area of stones was found inside the NW corner. What these areas of stones represent is not clear, possibly some sort of demolition layer rather than a cobble

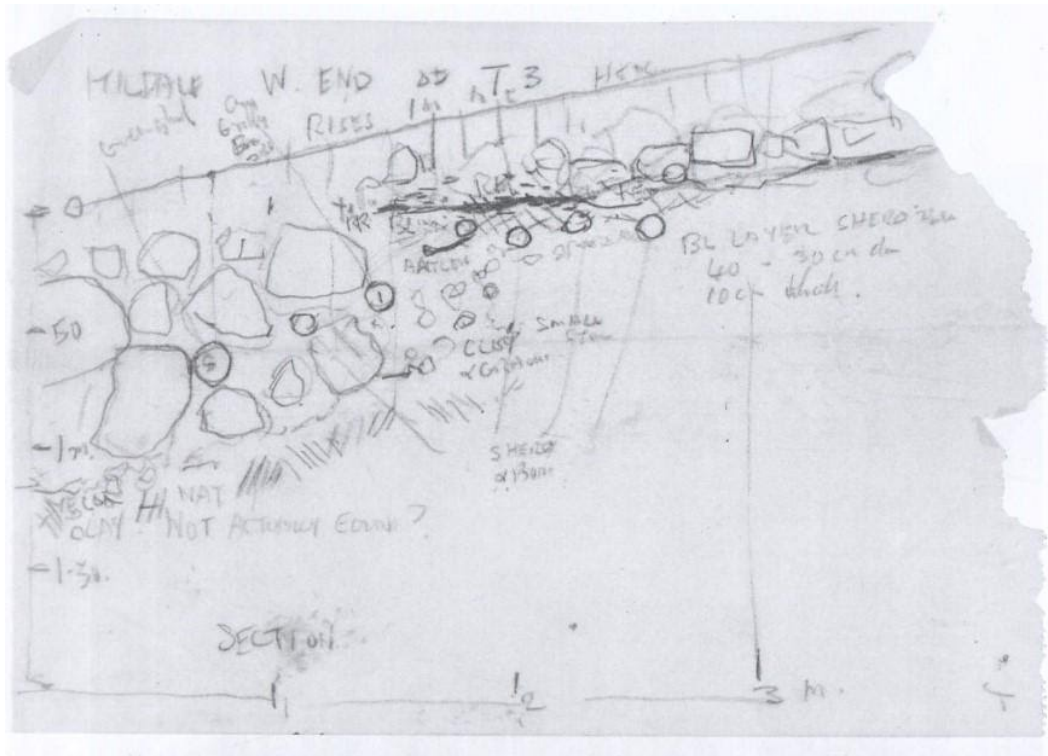
From the sections along the SE wall and near the SW corner and also from Raymond’s notes, there appears to have been three distinct layers under the topsoil.

Along the SE wall the uppermost layer is described as “60-100mm thick red burnt earth and sandy material” above a “yellow-brown clean sandy layer and chips of stone” above a layer of “black 100mm thick and 400-500mm down [depth from topsoil] with sherds, bones, an antler and ash” (see the above section).

Near the SW corner the uppermost layer is described as “red or brown shelly(?) subsoil with burnt material, stones and earth – some broken roofing tiles” above a layer of “yellow sandy clay” above a layer of “black 100-150mm thick. It contained ash, charcoal, bones and a few potsherds.....600mm from the turf level” (these quotes relate to the section in the middle of the building plan above).

Raymond describes the lowest layers, especially at the SW corner, as being a “destruction layer of an earlier building”. This may be true or it could have been an occupation layer, covered by a period of disuse, covered by a demolition layer.

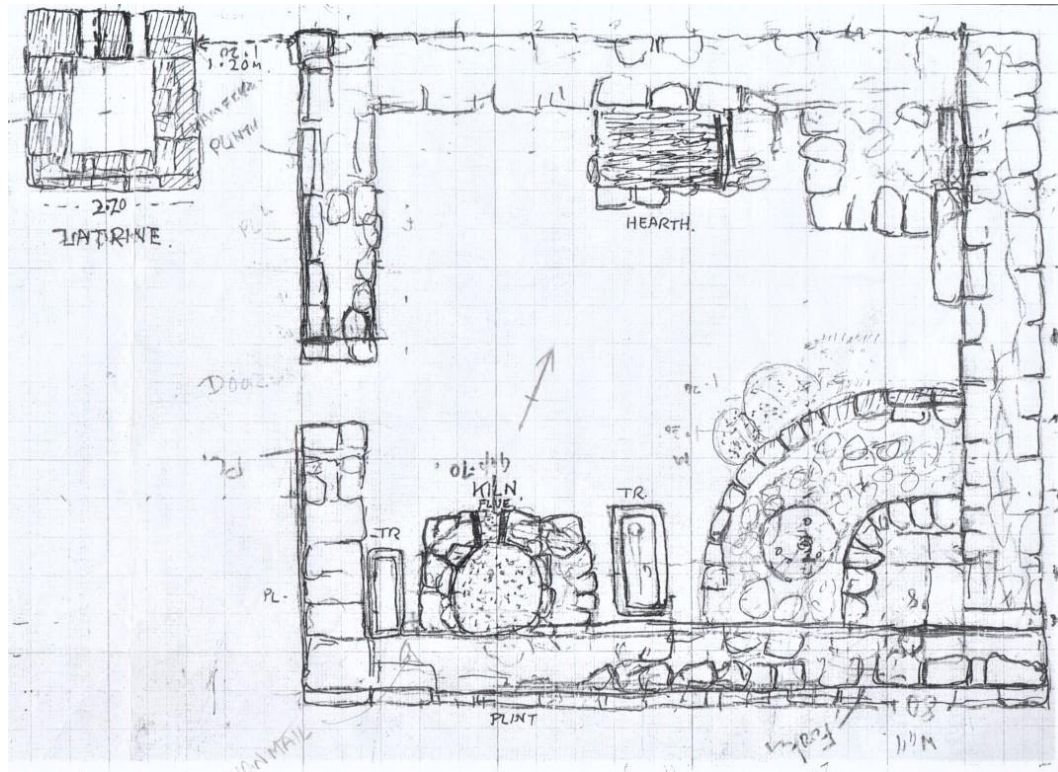
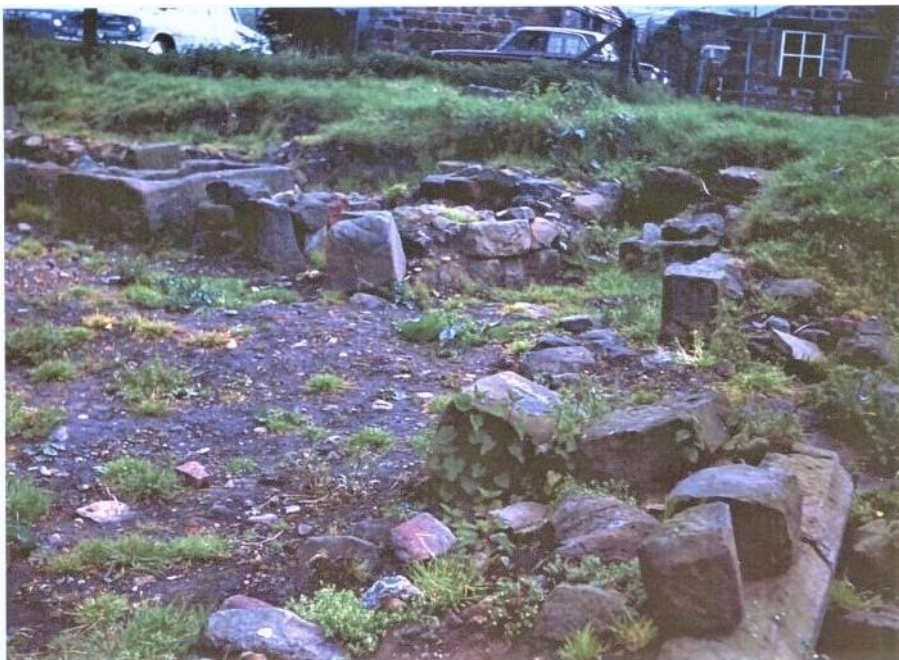
BUILDING B.

This building was found in 1957. There are two floor plan drawings (the plan above and a duplicate), one YAJ note and one note in the TSDASH relating to this building. Raymond

refers to it as being a workshop. The photograph was taken from the NE corner and is from the Tees Archaeology collection.

Inside the SE corner is an enigmatic curved single-quadrant line of stones forming a kerb about 0.5m high and between 3.0m and 3.5m in radius. There is another curved line of stones nearer the building corner about 0.3m higher again and about 1.6m in radius. It is thought that outer kerb was a later addition. There were three cracked millstones, 1.2m in diameter, found associated with this feature - one between the two curved lines and two on the (?) floor next to the outer kerb. Both features had a rubble filling some of which was burnt and also contained some roof slabs. Under the outer (and ?later) curved line of stones was found an area of burning about 1.2m in diameter and 50mm thick.

A small building was found 1.2m from the NW corner which was labelled as a Latrine (see above plan). It measured about 2.2m square externally with walls about 0.5m wide. There were two covered channels in its NW side measuring about 0.2m wide by 0.3m high.

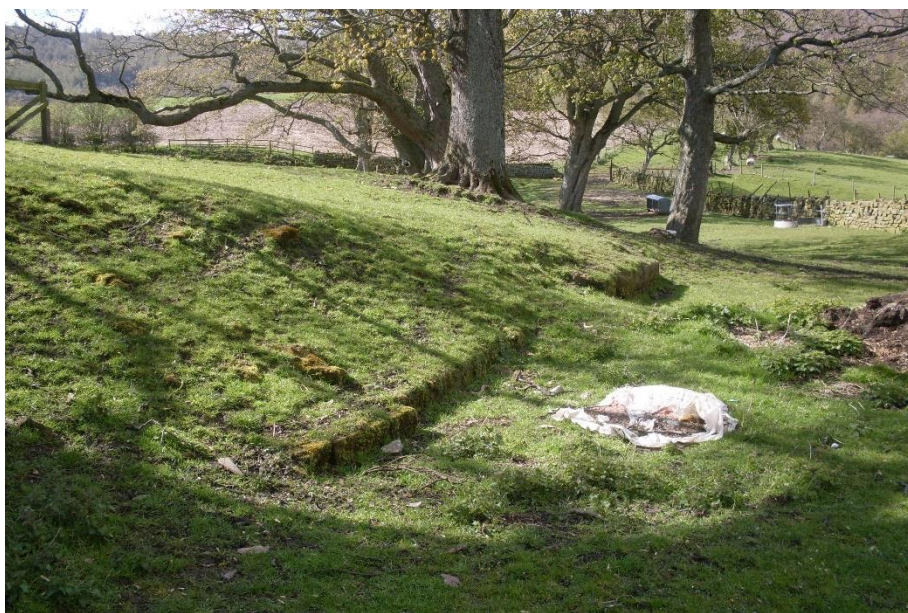
BUILDING D.

This building was found in 1969. There are two inked drawings of this building one of which is shown

above and the other is a duplicate. The NE elevation (on the right) is part of the same drawing. There are no sections relating to this building. The photograph shows it as it is today. Much of the interior appears to have not been excavated as evidenced by the "UN EX" on the plan.

The NE wall measured 11.9m externally and the NW wall was traced for 10.0m. The latter wall measured 2.0m wide with a central 0.7m gap in the masonry. The widths on the NE and SE walls were not determined. The SW wall was never found. There were three buttresses found – two on the SE corner which measured 1.2m long by 0.15m wide and one on the NE corner 1.4m wide by 0.15m. The outer face of the NE wall was constructed using ashlar blocks but there were no signs of any chamfer. The NW wall appears to have a rubble filling with some ashlar faced blocks. Part of the NE wall was traced for 1.8m below present ground level and appears to sit on two off-set foundation blocks (see section below). A mason's mark in the form of a vertical arrow was found on the buttress at the NE corner.

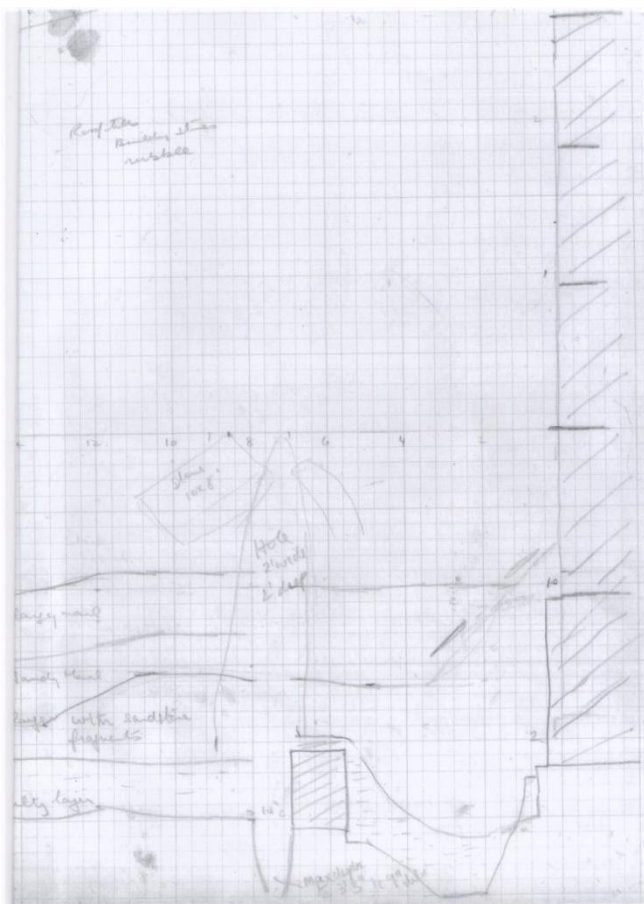
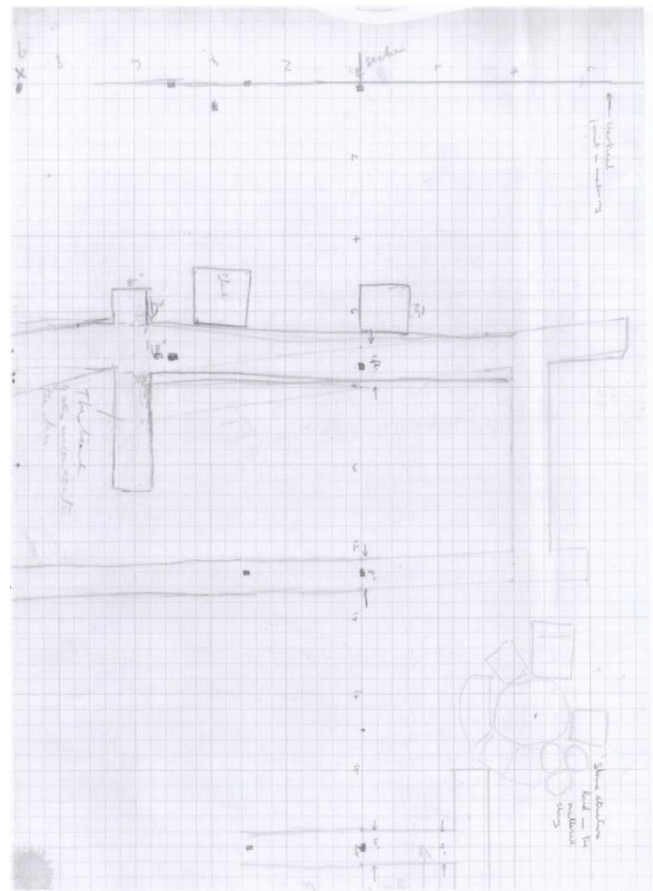
The drawing on the left is a section of the ditch and the drawing on the right is a plan of some inter-locking timbers found at the

bottom of the ditch. This ditch was found in a huge excavation trench visible on an air-photograph taken in 1972 although it is probable that the true width of the ditch was

The lowest layer in the ditch is described as “silty”, the one above as a “sandy layer with sandstone fragments”, the next as “sandy material”, the uppermost as “clayey”. All four layers are bracketed together as “pottery layers”. It must be assumed that all four were the original silting or occupation levels. The layer between these four and the present ground level is described as “rubbly” and is probably the demolition layer in which window heads, mouldings, dressed and ornamental stones, battlements, pointed windows and an arm of an Anglo-Saxon cross were found.

Some large cut timbers were found on the floor of the ditch with cross-sections of between 200mm and 300mm square. It is thought that these timbers were part of a bridging structure across the ditch which could be the case because they were found still morticed together and appear not to have been randomly thrown into the ditch. Also on the ditch floor was an “inverted parapet” and a circular stone structure measuring about 0.75m in diameter and “laid on the natural clay”.

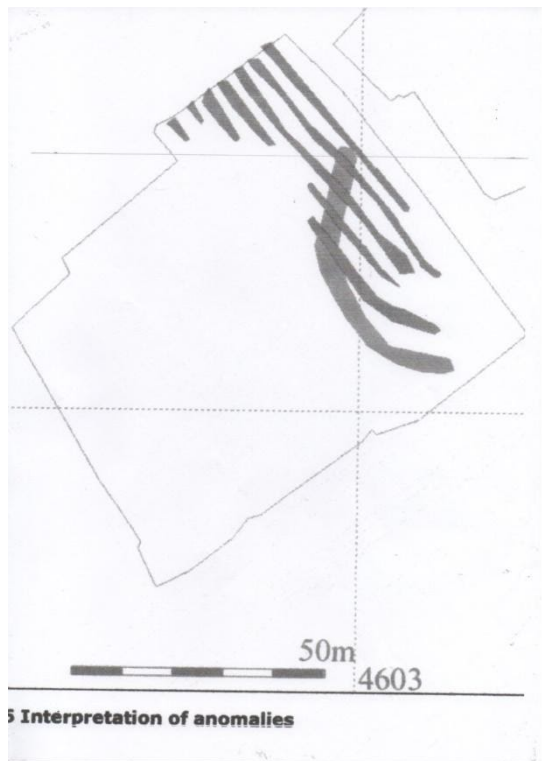
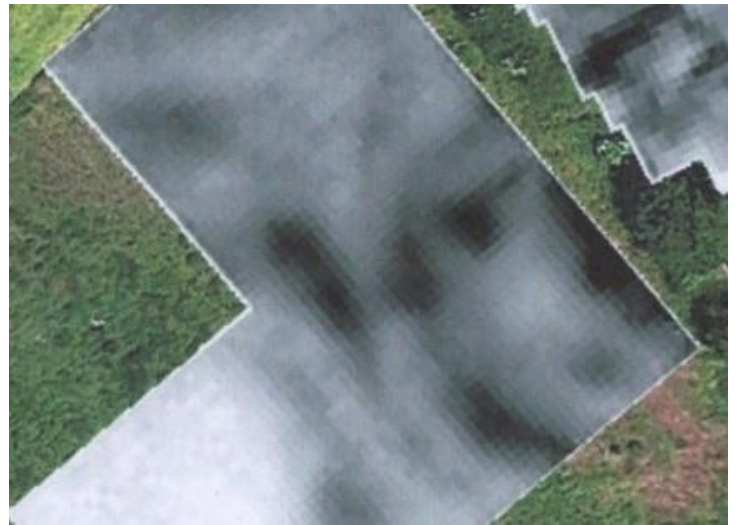
The magnetometer survey is on the left and the resistivity survey is on the right. See also the topographical survey at the start of this section of this Review for the ditch location.

Both surveys revealed a curved ditch about half-way up the slope from the bottom of the valley. The ditch on the magnetometer survey is self-evident but the ditch alignment on the resistivity survey is more difficult to see. It is the curving white band between the two black areas. The large white area at the bottom left of the above plan is the valley bottom.

The magnetometer survey also revealed some rigg and furrow over the top of the ditch in the stubble field. These are just visible on the ground in a favourable light conditions. As can be seen on the survey, they cover a very limited area on one of the steepest parts of the stubble field and nowhere else.

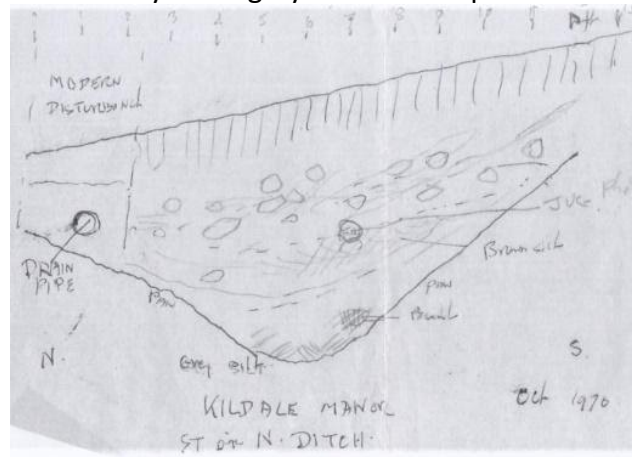
However, in 1970 they did find a ditch in one of their trenches approximately 7m north of building B and there is a mention of another ditch on the same line somewhere nearby. The excavation trench for the former ditch is visible also on the 1972 air-photograph. There are two section drawings of it – one site sketch and a copy of it which is shown below. There is also a paragraph in the TSDASJ.

The ditch was found to be 4m wide and about 2m deep dug into clay. There were three fill layers found. The uppermost appears to be full of stones and gravel, under which is a brown silt with pottery and the lowest layer is a grey silt with lumps of burnt material in it.

A large timber beam was found in the lowest grey silt layer. It measured 3m long and about 100mm wide. It had two mortice slots in it about 600mm apart and a series of eight round 25mm diameter holes in it about 220mm apart.

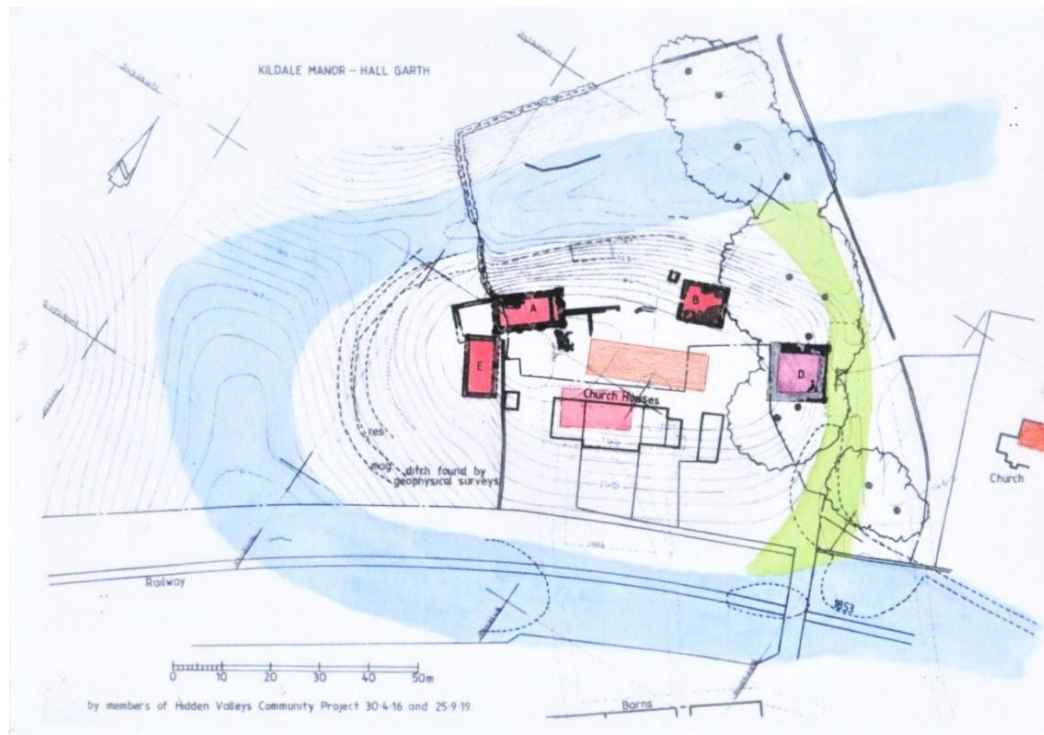
The plan above shows the speculative position of a Viking hall (in brown) measuring 24m by 7m occupying the highest part of the hillock. It would probably have been built of timber and was obviously not the original hall, possibly the eighth generation.

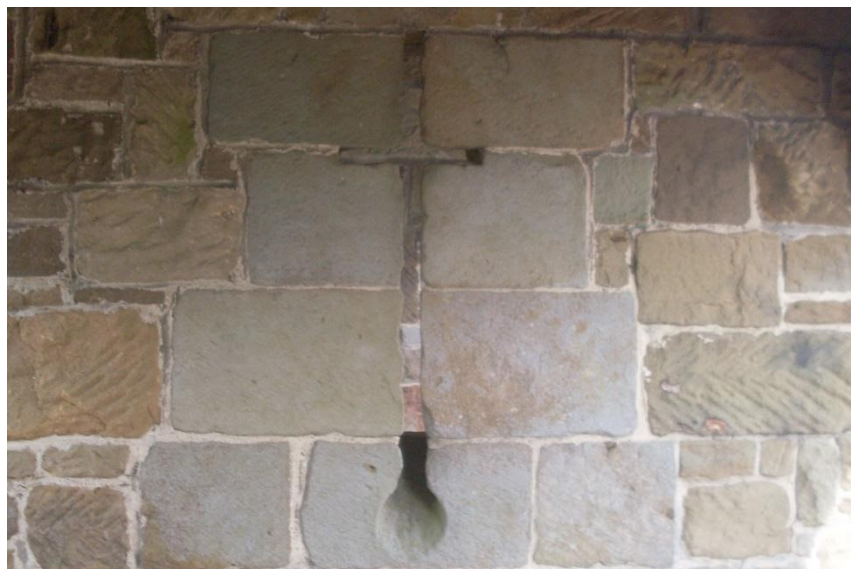
Above is the arrow-slit reconstructed in the archway into Church Houses, Kildale village. The sloping bowl at the bottom is possibly a device to enable archers to fire at their opponents from a very steep downward angle which would only work if the arrow-slit was

on either the first or second floors. If this arrow-slit has come from the Manor House site, then it implies that the tower (D) had at least two floors.

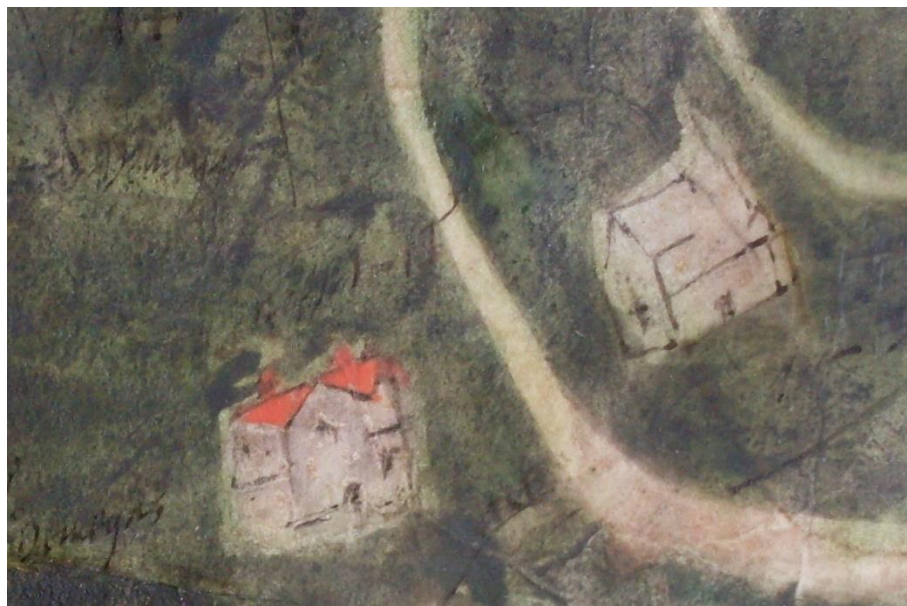
The estate map shows the positions of 19 houses on either side of the main road through the village, together with the manor house, church and minor roads.

The above extract shows the manor house on the left, the Medieval Kildale to Lonsdale road and the church with some sort of tower at the wrong end. The tower is invariably at the western end of a church.

From the above extract the manor house appears to be a two-storey T-shaped house with a southern wing and gable attached to a through-passage building. In the gable there is a (?) front door. If the church was drawn the wrong way round (as correctly observed from the north) then perhaps the manor house was also drawn the wrong way round with the front door opening onto the courtyard.

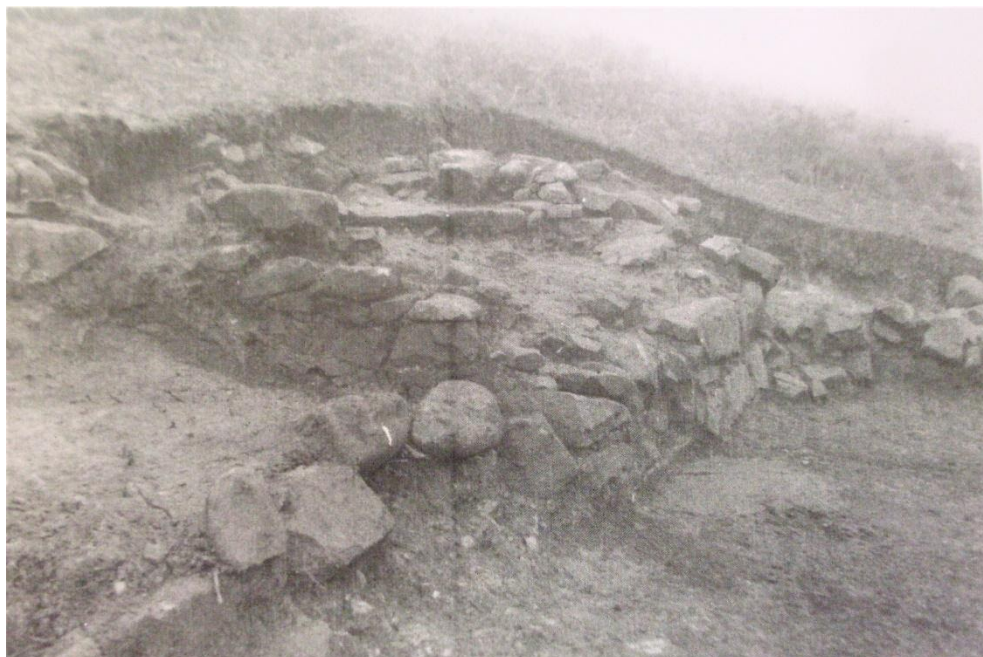
The second is a substantial stone building seen in the photographs in the Tees Archaeology collection. There are no references to it on any of the plans or notes in any of the archives. It is amongst other Kildale manor photographs and the topographical profile seen in the photograph below is very similar to the gradient of the valley side as it levels out near the valley bottom below building A.

The building appears to measure about 2m square with substantial walls about 600mm thick. There is a blocked doorway on the downward side with an external threshold slab.

The substantial stone structure discussed in the preceding section in this Review (Shortcomings) and illustrated in the photograph is not located on any plans, notes or paragraphs relating to the earlier excavations. However, it was amongst other photographs that supposedly relate to the excavations and as noted above the gradient of grass bank in the photograph is very similar to that of the bank below building A as it levels out towards the bottom of the valley adjacent to the Kildale Manor site. The structure measures about 2m square with walls about 0.6m wide with a blocked door on its lower side with a large external threshold slab.
