SURVEY OF EXCAVATED BUILDINGS AT KILDALE MANOR.

The following pages will describe the five buildings excavated between 1957 and 1976 by Roland Close, Raymond Hayes, Don Spratt and many other helpers.

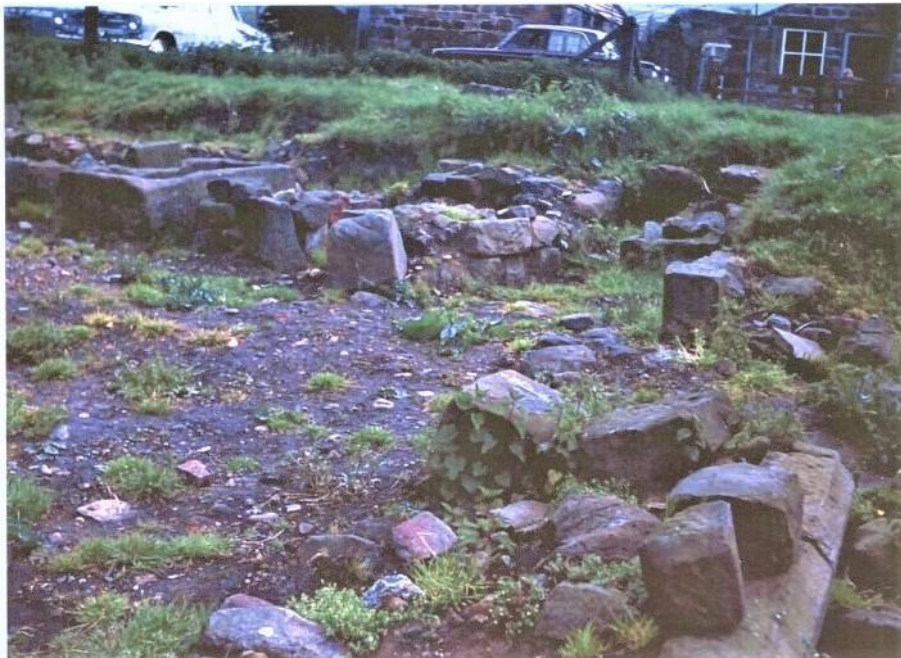
BUILDING B.

This building was found in 1957. There are two floor plan drawings (the plan above and a duplicate), one YAJ note and one note in the TSDASH relating to this building. Raymond

refers to it as being a workshop. The photograph was taken from the NE corner and is from the Tees Archaeology collection.

The NE and SW walls measured 8.6m externally or 6.7 internally and the NW and SE walls measured 9.5m externally and 7.6m internally. There was a 0.8 wide doorway in the SW wall. The above photograph clearly shows an ashlar stone plinth with a chamfer on its outer face NW of the entrance. However the above plan shows plinths along the entire lengths of SW and SE walls. The type and quality of the flooring in this building was not recorded. There are six features inside the building:

There is no doubt that this building was changed over the years as evidenced by the two butt joints emphasised on the drawing at the SE and NE corners.

A small building was found 1.2m from the NW corner which was labelled as a Latrine (see above plan). It measured about 2.2m square externally with walls about 0.5m wide. There were two covered channels in its NW side measuring about 0.2m wide by 0.3m high.

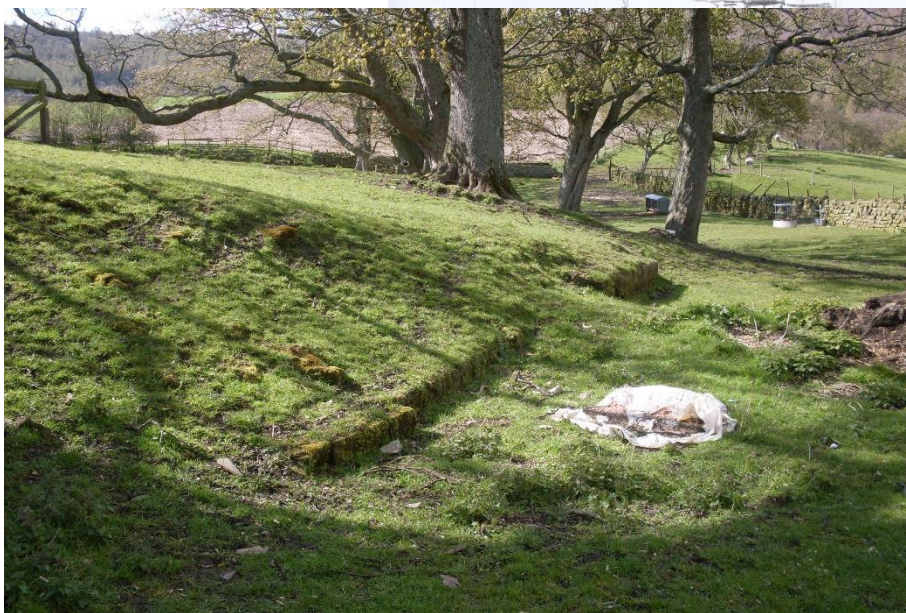
BUILDING D.

building was found in 1969. There are inked drawings of this building one of which is shown above the other

duplicate. The NE elevation (on the right) is part of the same drawing. There are no sections

relating to this building. The photograph shows it as it is today. Much of the interior appears to have not been excavated as evidenced by the "UN EX" on the plan.

The NE wall measured 11.9m externally and the NW wall was traced for 10.0m. The latter wall measured 2.0m wide with a central 0.7m gap in the masonry. The widths on the NE and SE walls were not determined. The SW wall was never found. There were three buttresses found – two on the SE corner which measured 1.2m long by 0.15m wide and one on the NE corner 1.4m wide by 0.15m. The outer face of the NE wall was constructed using ashlar blocks but there were no signs of any chamfer. The NW wall appears to have a rubble filling with some ashlar faced blocks. Part of the NE wall was traced for 1.8m below present ground level and appears to sit on two off-set foundation blocks (see section below). A mason's mark in the form of a vertical arrow was found on the buttress at the NE corner.

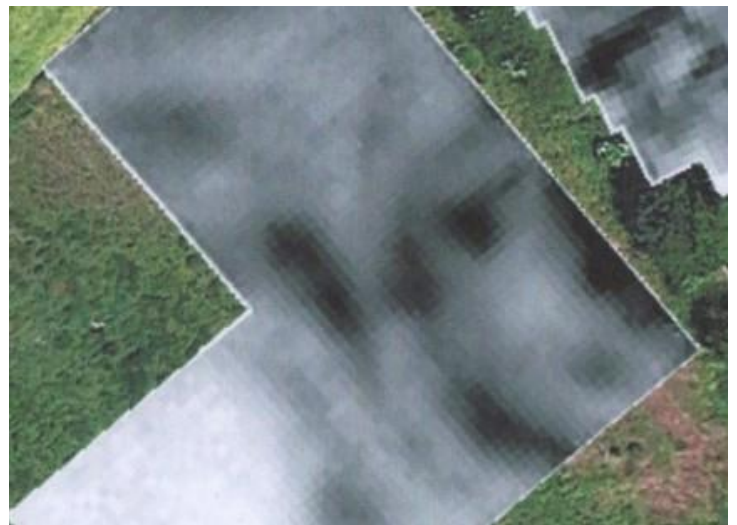
The magnetometer survey is on the left and the resistivity survey is on the right. See also the topographical survey at the start of this section of this Review for the ditch location.

Both surveys revealed a curved ditch about half-way up the slope from the bottom of the valley. The ditch on the magnetometer survey is self-evident but the ditch alignment on the resistivity survey is more difficult to see. It is the curving white band between the two black areas. The large white area at the bottom left of the above plan is the valley bottom.

The magnetometer survey also revealed some rigg and furrow over the top of the ditch in the stubble field. These are just visible on the ground in a favourable light conditions. As can be seen on the survey, they cover a very limited area on one of the steepest parts of the stubble field and nowhere else.
